ARCHITECTURAL/HISTORICAL COMPONENT FORM

- 1) Resource No. 5CF279 2) Temp No. 68 3) Name Union Block (Salida Sweet Shop)
 4) Address 130 W. First 5) District Name Salida Commercial District
 I. INTEGRITY: 6) Condition: Good Fair Deteriorated
 7) Original Use commercial property 8) Present Use commercial property
 9) Original Site Moved Date(s) of Move: _____
 10) Unaltered Altered Explain: Transom area covered; display windows
modified.

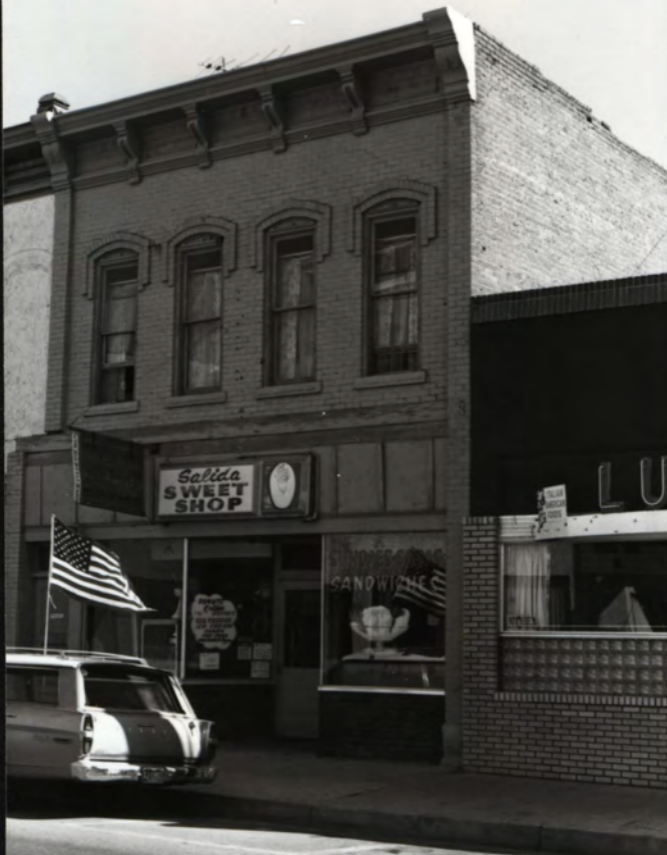
Frame Number 18
 Roll Number 0F4
 Facade Orientation S

Identified as the Union Block on the 1890 Sanborn map, this two story brick commercial structure is characterized by a bracketed metal cornice and twelve segmental arch openings accented by brick window hoods (one window flanked by pilasters has been removed). The middle portion of the building has been stuccoed (see resource nos. 5CF280-281) and various alterations to the original storefront areas are visible.
