ARCHITECTURAL/HISTORICAL COMPONENT FORM

1) Resource No. 5CF303 2) Temp No. 92 3) Name Cranberry Kitchen
4) Address 137 E. First 5) District Name Salida Commercial District

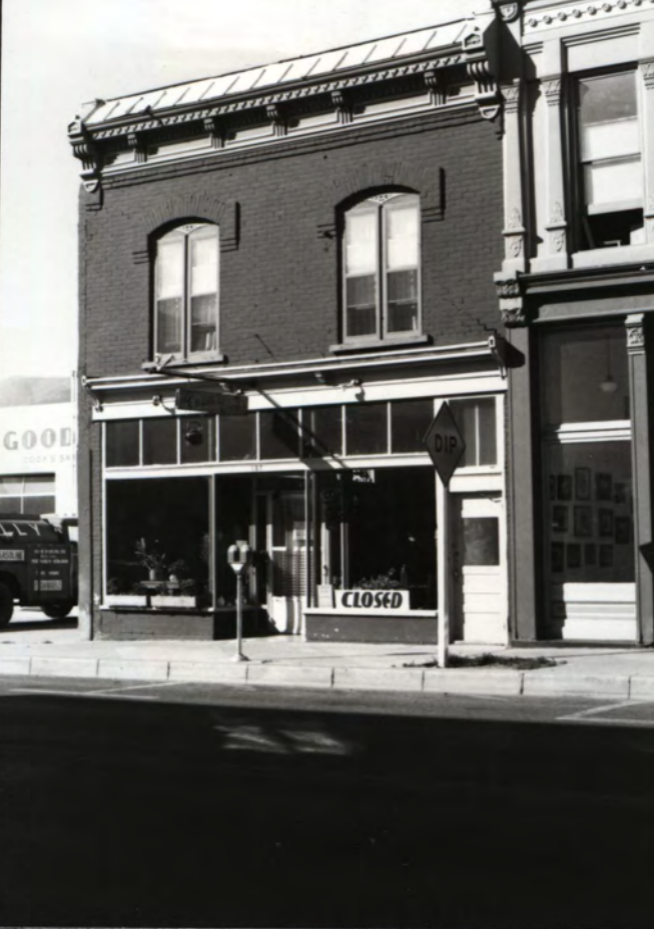
Frame Number 11
 Roll Number CF6
 Facade Orientation N

Special Features/Surroundings: The building continues the pattern of cornice, window, and storefront alignment evident in the district

The structure is characterized by a bracketed metal cornice, two segmental arch openings accented by brick window hoods (the large openings are composed of paired bays), and a bracketed lintel separating the second story from the storefront area. Below the lintel is a transom window stretching the width of the building, a recessed entrance framed by display windows and a side entrance.
