ARCHITECTURAL/HISTORICAL COMPONENT FORM

1) Resource No. 5CF273 2) Temp No. 62 3) Name Victoria Tavern
4) Address 143 North F 5) District Name Salida Commercial District

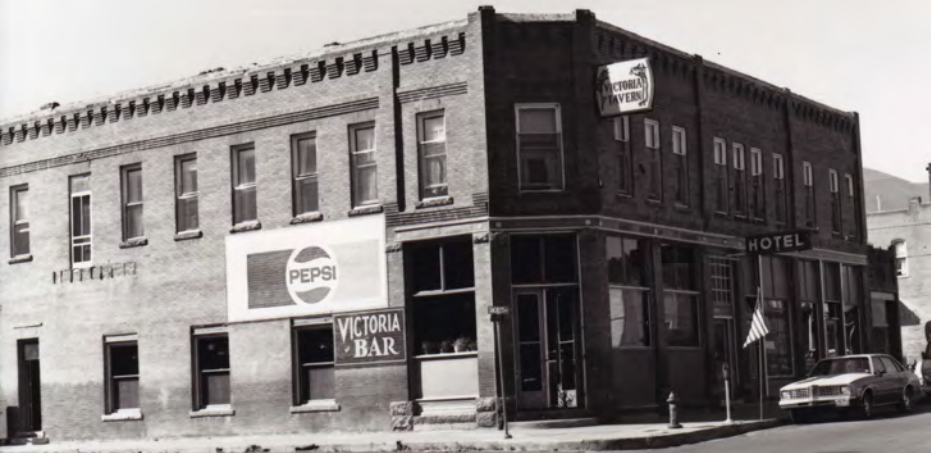
Frame Number 12
Roll Number CF4
Facade Orientation W

10) Unaltered ___ Altered Explain: Windows on lower level floor
modified - brick and metal siding added

The structure currently housing the Victoria Tavern is a two story brick building featuring a corbel table at the cornice line. On the street facade the upper story bays are arranged 3-4-3 and separated by pilasters. These openings and those on the north facade are demarked by cut stone sills. The building has a corner entrance and three entrances on F Street.
