ARCHITECTURAL/HISTORICAL COMPONENT FORM

1) Resource No. 5CF229 2) Temp No. 18 3) Name Montgomery Wards
4) Address 148 F Street 5) District Name Salida Commercial District

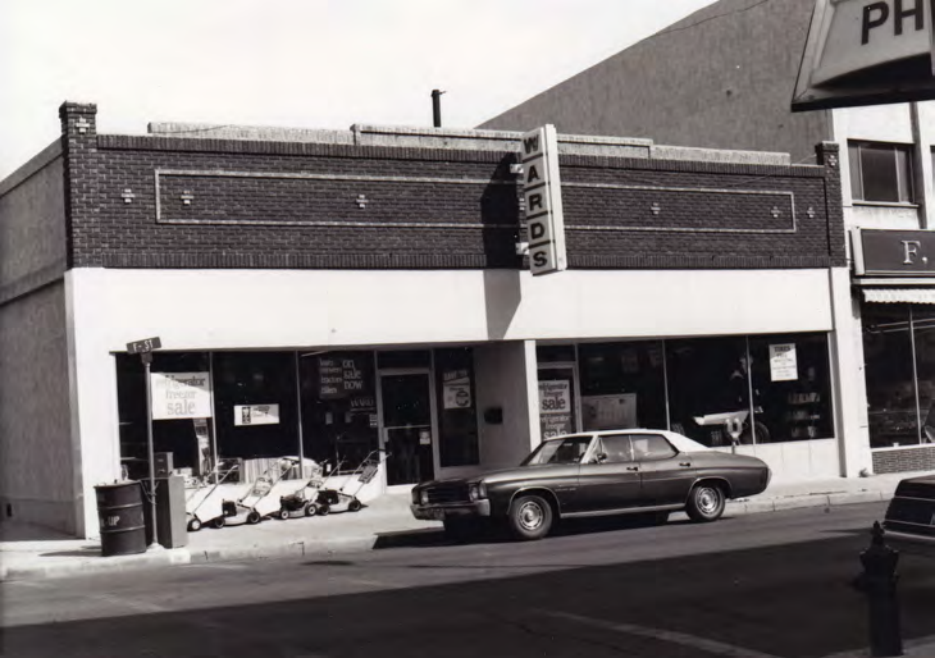
Frame Number	<u>21</u>
Roll Number	<u>CF1</u>
Facade Orientation	<u>E</u>

10) Unaltered Altered Explain: This building was most likely remodeled in the 1920s-30s. A new brick facade was added and the rest of the brick building covered with stucco.

The building as it now appears features simple brickwork patterns and a modernized (new windows, etc.) storefront area. Despite these changes, the structure plays a contributing role in the district for its construction material and size, and shape are consistent with other district buildings. (See the PSC building, resource No. 5CF247 which closely resembles this structure)
