ARCHITECTURAL/HISTORICAL COMPONENT FORM

- 1) Resource No. 5CF290 2) Temp No. 79 3) Name Energy Broker
 4) Address First & G Streets 5) District Name n/a
 I. INTEGRITY: 6) Condition: Good Fair Deteriorated
 7) Original Use commercial property 8) Present Use commercial property
 9) Original Site Moved Date(s) of Move: _____
 10) Unaltered Altered Explain: _____

3)Resource Name Energy Broker 4)Project Name FCRC Survey

23)Report Title Historical Surveys of Colorado Communities: Upper Arkansas Valley, Salida

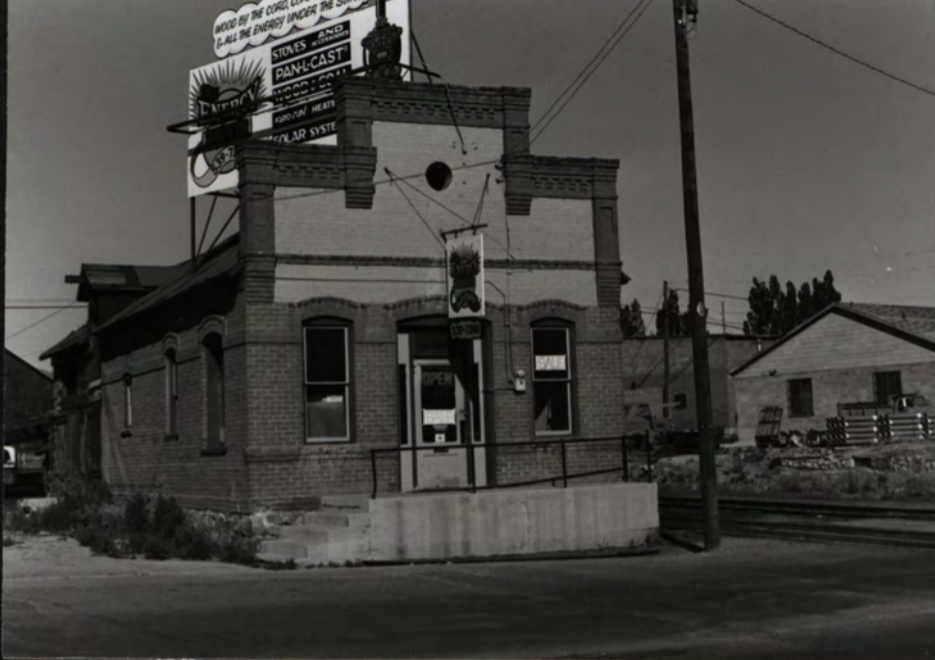
Frame Number 10
Roll Number CF5
Facade Orientation N

The one story brick structure has a gable roof and a stepped parapet featuring brick work patterns. A small rose window is in the center of the parapet. A central entrance flanked by segmental arch bays (the entrance is also segmentally arched) completes the facade. To the rear of the building are the remains of coal and lime bins (wooden structures).

Recreation Construction ; Comments The roof and the rear portion of the building are in need of repair

20)Management Recommendations maintenance work is required
