ARCHITECTURAL/HISTORICAL COMPONENT FORM

- 1) Resource No. 5CF249 2) Temp No. 38 3) Name Amaranth
 4) Address 229 F Street 5) District Name Salida Commercial District
 I. INTEGRITY: 6) Condition: Good Fair Deteriorated
 7) Original Use commercial property 8) Present Use commercial property
 9) Original Site Moved Date(s) of Move: _____
 10) Unaltered Altered Explain: wood sign over transom area

- 16) Archaeological Potential: Yes No Unknown Explain: _____

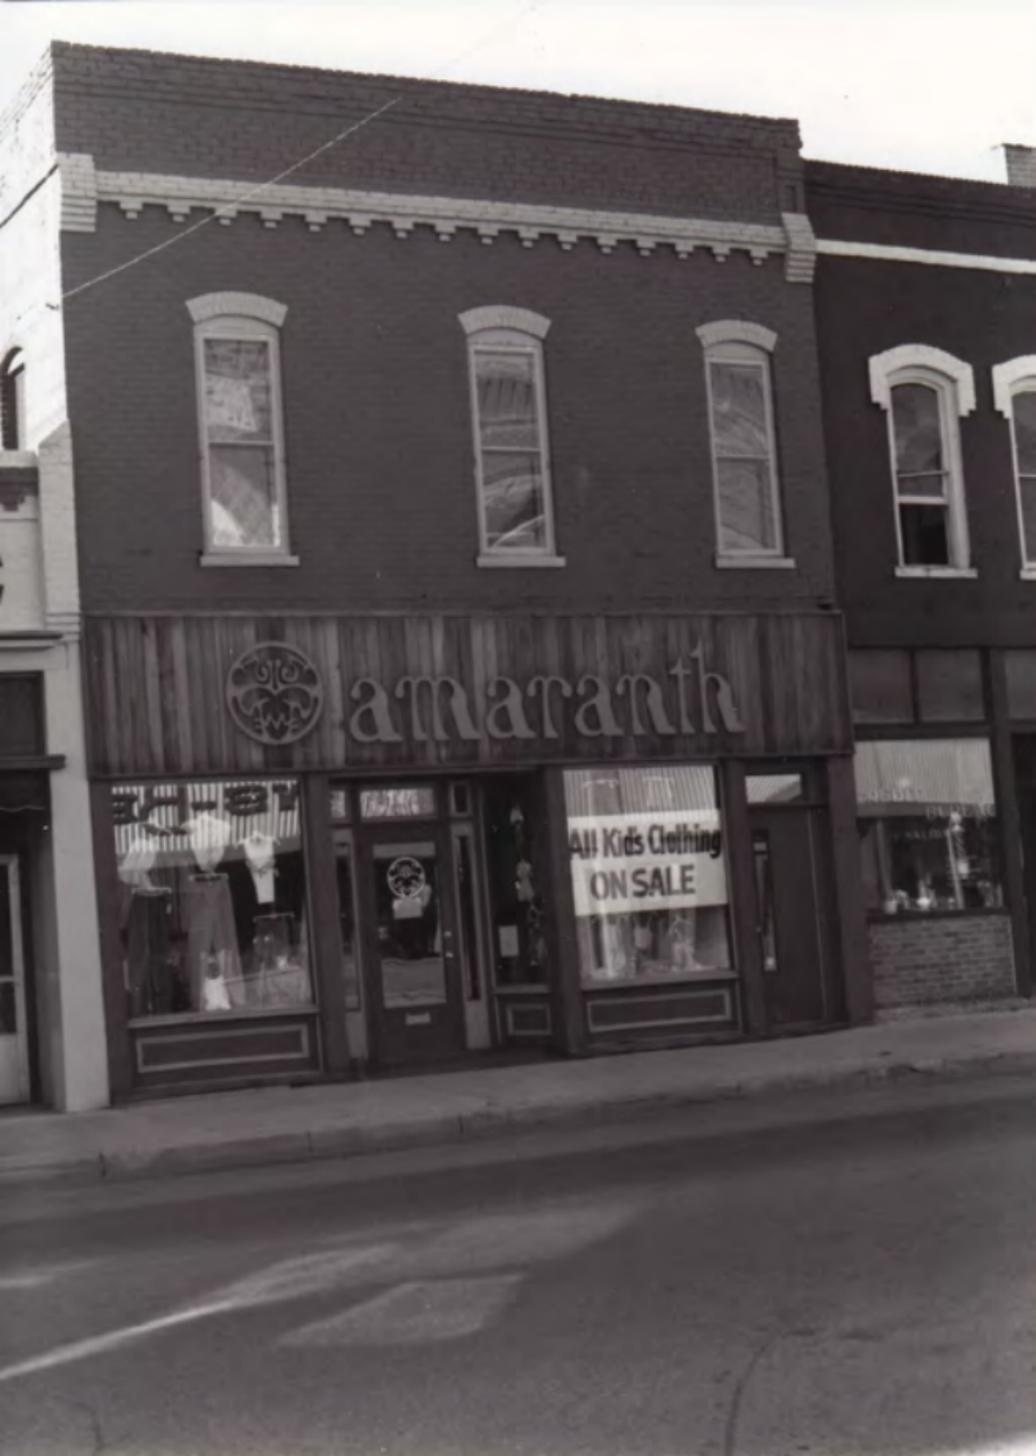
Frame Number 7
 Roll Number CF3
 Facade Orientation W

A two story brick commercial building characterized by a corbel table somewhat below the cornice line, three narrow segmental arch bays with small window caps, and an "almost intact" storefront -- only the transom area has been altered. Below the transom area is a recessed entrance accented by sidelights and its own transom. Of interest are the kickplates (the panels beneath the display windows) which are wood - originally the most common material for these panels. (on most commercial buildings the kickplates have been covered by various other materials).
