ARCHITECTURAL/HISTORICAL COMPONENT FORM

- 1) Resource No. 5CF248 2) Temp No. 37 3) Name Credit Bureau/Pizza Dispatch
 4) Address 233 F Street 5) District Name Salida Commercial District
 I. INTEGRITY: 6) Condition: Good Fair Deteriorated
 7) Original Use commercial property 8) Present Use commercial property
 9) Original Site Moved Date(s) of Move: _____
 10) Unaltered Altered Explain: Window alterations, brick siding below
display windows (kickplate area)

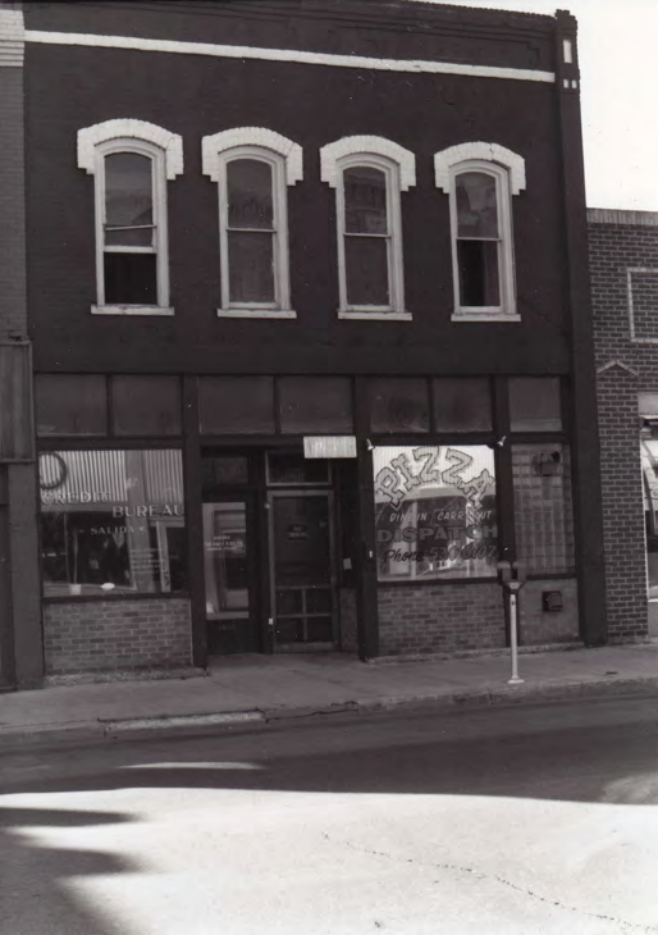
Frame Number 6
 Roll Number CF3
 Facade Orientation W

This two story brick commercial structure features very simple brickwork patterns at the cornice, four segmental arch bays accented by brick window caps, and a storefront area distinguished by a continuous transom, a double recessed entrance, and flanking display windows. This building and its neighbor (resource No. 5CF249) are the oldest structures on the east side of the block.
