ARCHITECTURAL/HISTORICAL COMPONENT FORM

1) Resource No. 5CF263 2) Temp No. 52 3) Name PT's Polish Corner

4) Address 100 blk. North F east side 5) District Name Salida Commercial District

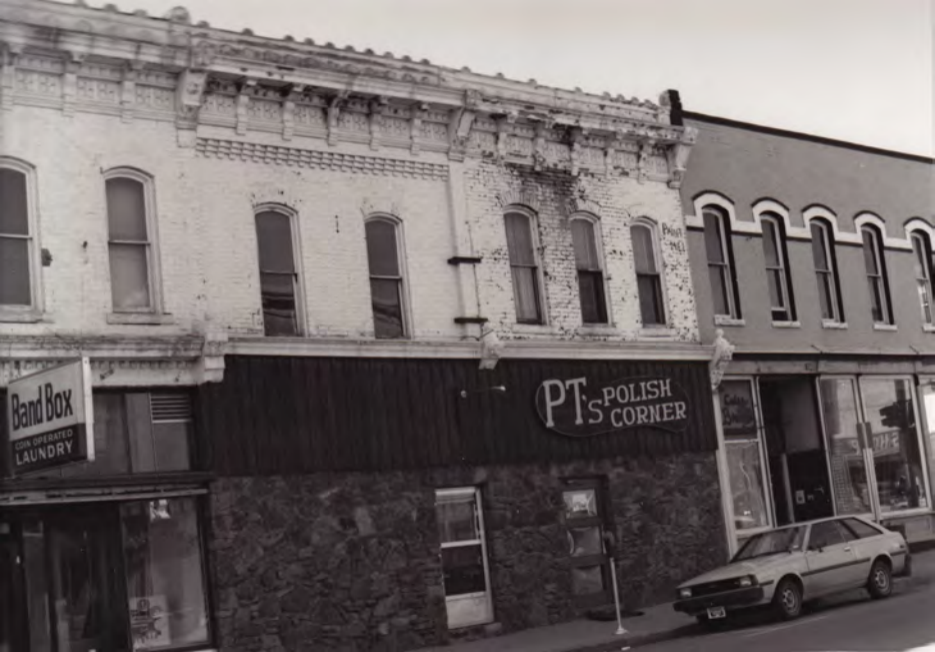
Frame Number 21
Roll Number CH 3
Facade Orientation W

10) Unaltered Altered Explain: stone and wood siding obliterates the lower facade

15) Special Features/Surroundings: A row of buildings (resource nos. 5CF270-272 in addition to these structures) which are almost identical in design. Common features include a continuous metal cornice connecting all structures, segmental arch bays, and a continuous lintel above the storefront areas.

These two brick buildings, currently housing one business establishment, were constructed at the end of the nineteenth century (the north half, 1886-1890; the south half 1890-1893). They are similar two story commercial structures, with a continuous bracketed cornice connecting them. A lintel above the now-altered storefront area is also evident. The southern portion has three segmental arch bays highlighted by radiating voussoirs. The northern portion has two segmental arch bays also accented by voussoirs. A corbel table underlines the metal cornice.
