COLORADO CULTURAL RESOURCE SURVEY

# Architectural Inventory Form

1. **Resource Number:** 5CF2231 **Parcel Number:** 380705130075  
2. **Temporary Resource Number:** 104 **SHF/CLG Grant Number:** CO-06-017  
3. **County:** Chaffee  
4. **City:** Salida  
5. **Historic Building Name:** Chapman/Mahar House  
6. **Current Building Name:** N/A  
7. **Building Address:** 224 D Street  
8. **Owner Name and Address:** Jones, Eileen and K. Steven, P.O. Box 773611, Steamboat Springs, CO 80477

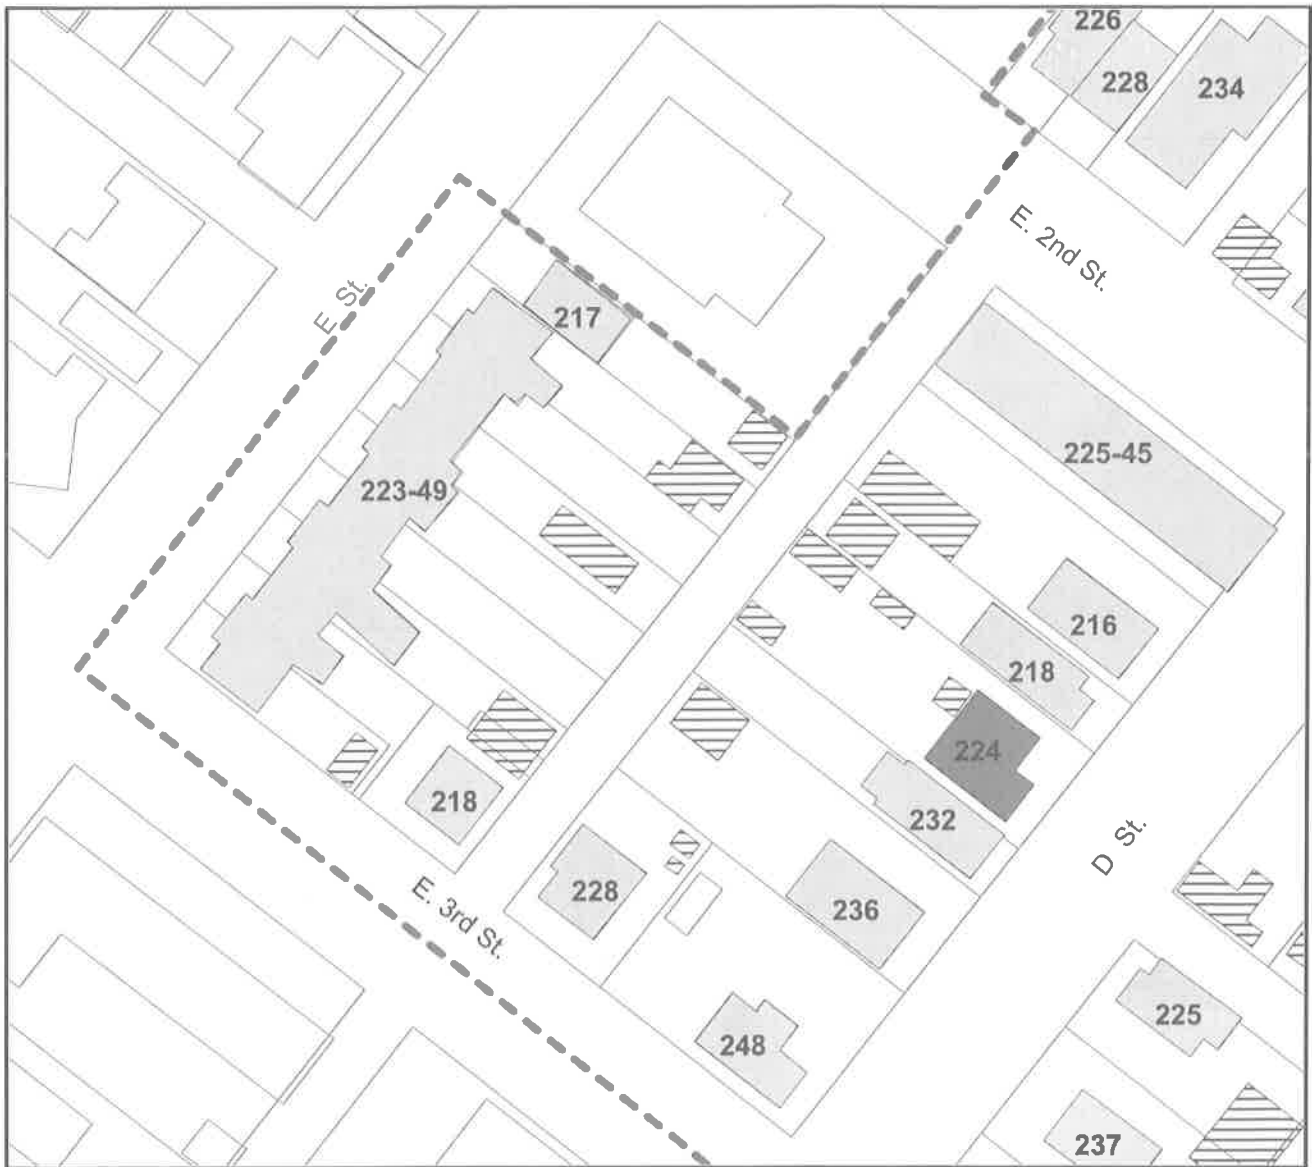
224 D Street

SOURCE: Building outlines from CAD file provided by City of Salida (and supplemented by fieldwork) and overlaid on parcels produced by Chaffee County. The resource described by this survey form is darkly shaded.
