COLORADO CULTURAL RESOURCE SURVEY

Architectural Inventory Form

1. **Resource Number:** 5CF2281 **Parcel Number:** 380705129066
 2. **Temporary Resource Number:** 86 **SHF/CLG Grant Number:** CO-06-017
 3. **County:** Chaffee
 4. **City:** Salida
 5. **Historic Building Name:** Shay House
 6. **Current Building Name:** Margos House
 7. **Building Address:** 303 E. Second Street
 8. **Owner Name and Address:** Margos, Nicholas Charles and Barbara Lee, 303 E. 2nd St., Salida, CO 81201

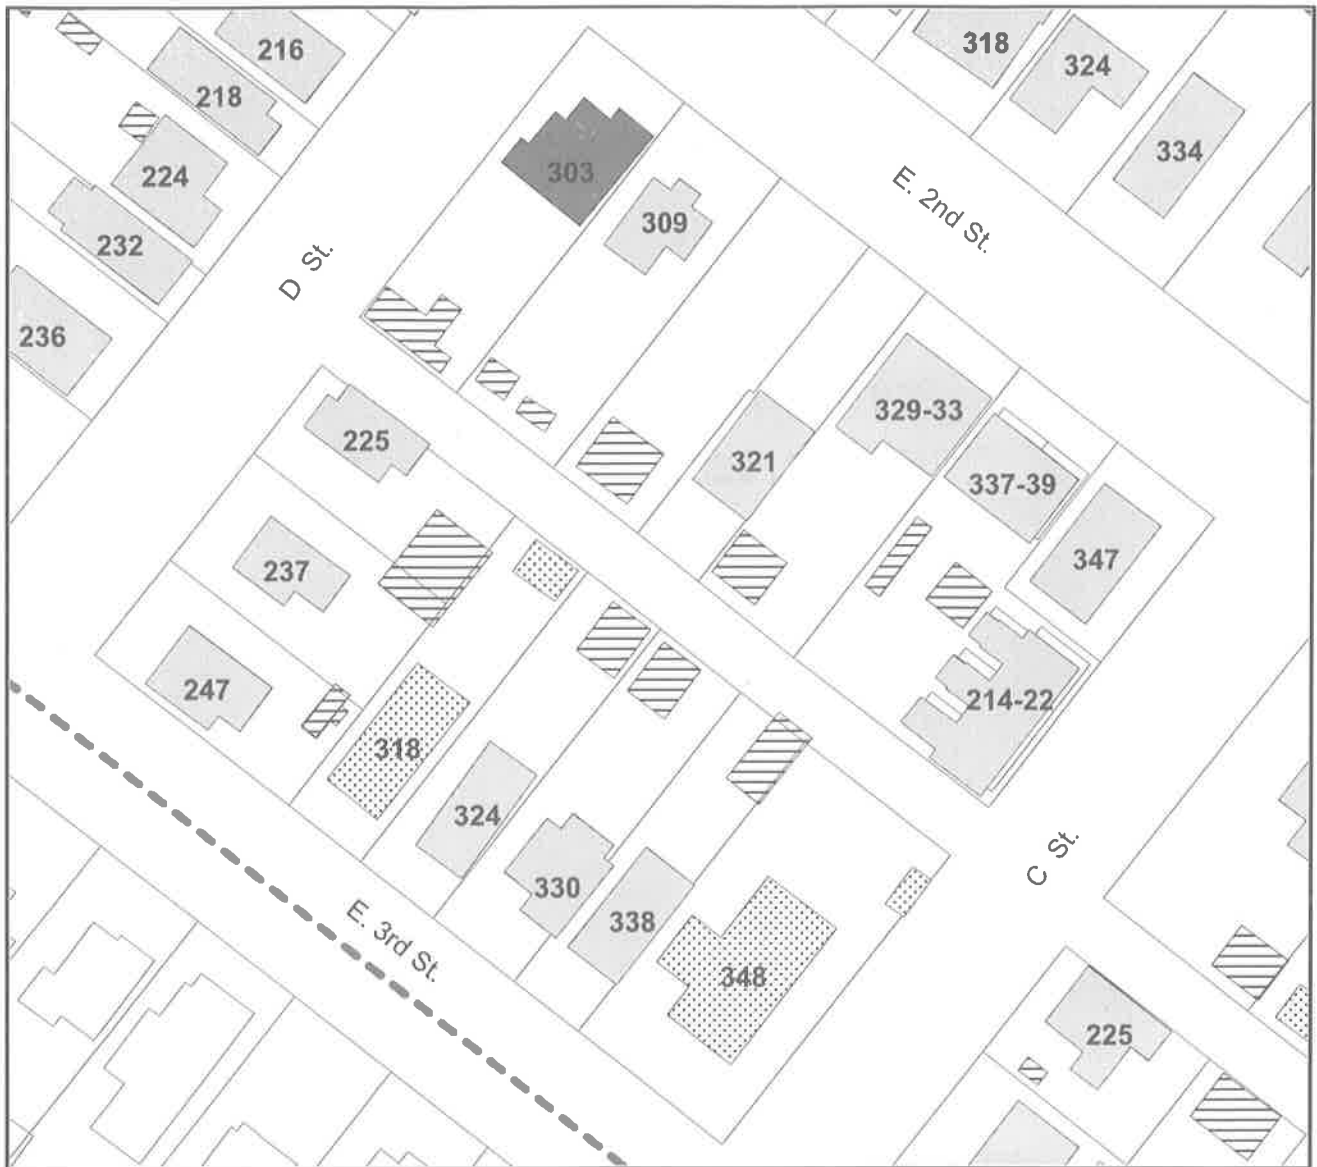
303 E. Second Street

SOURCE: Building outlines from CAD file provided by City of Salida (and supplemented by fieldwork) and overlaid on parcels produced by Chaffee County. The resource described by this survey form is darkly shaded.
