COLORADO CULTURAL RESOURCE SURVEY
Architectural Inventory Form

1. Resource Number: 5CF2272
2. Temporary Resource Number: 9
3. County: Chaffee
4. City: Salida
5. Historic Building Name: Banks/Giron House
6. Current Building Name: N/A
7. Building Address: 319 E. Sackett Avenue
8. Owner Name and Address: Archuleta, Jose B. and Gloria M., P.O. Box 582, Poncha Springs, CO 81242
- Parcel Number: 368132402044
SHF/CLG Grant Number: CO-06-017

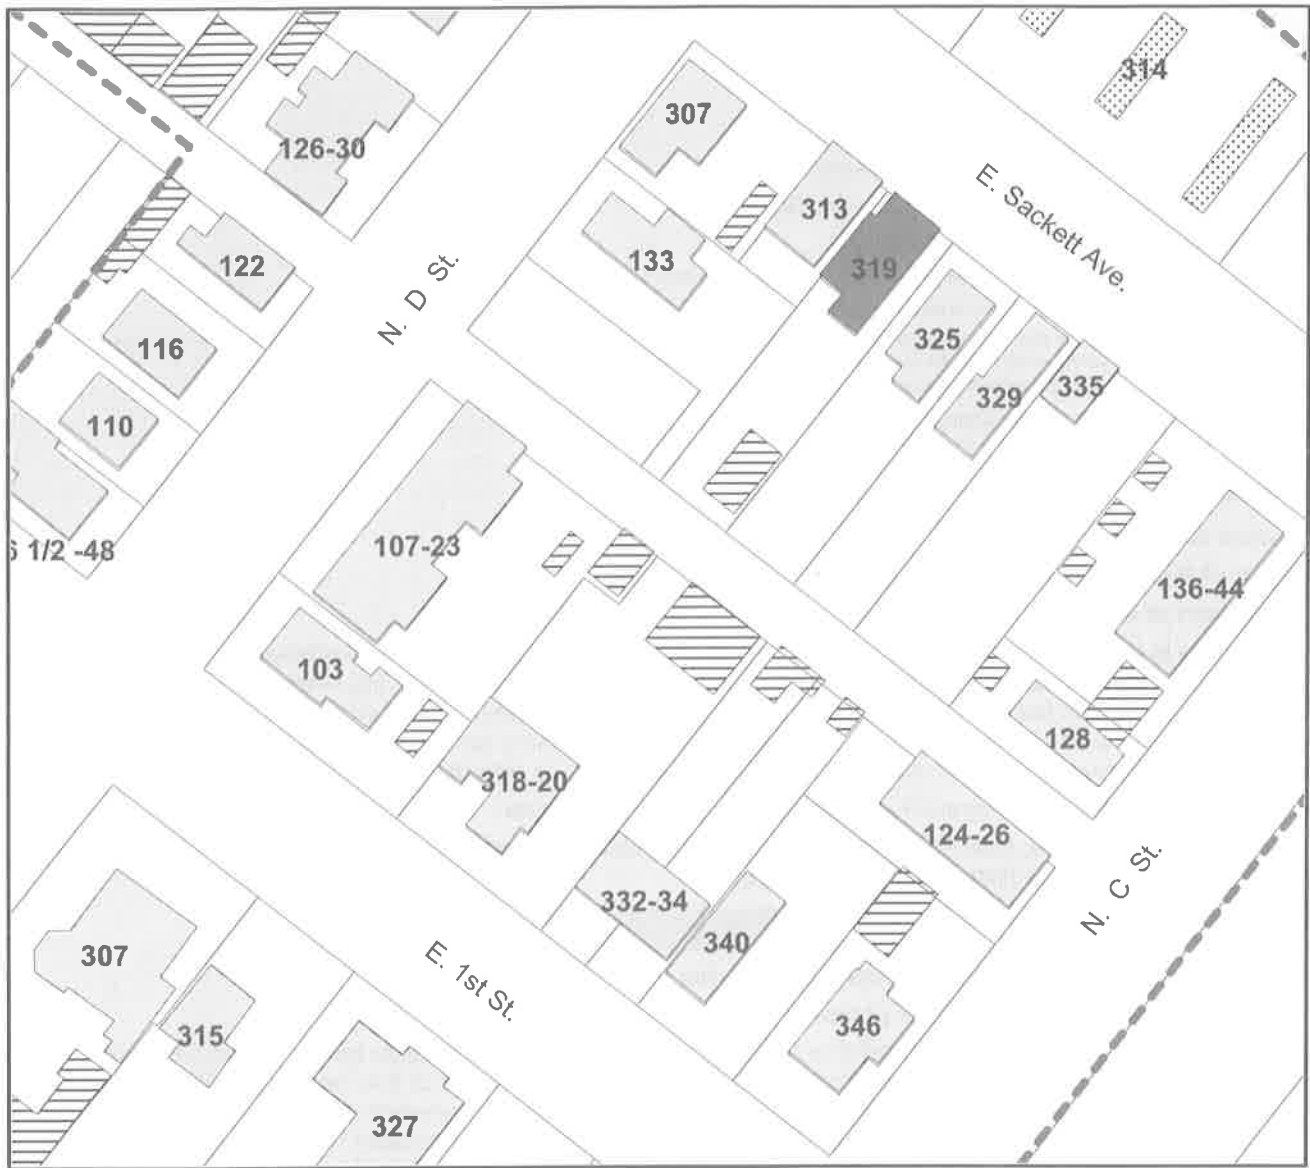
SOURCE: Building outlines from CAD file provided by City of Salida (and supplemented by fieldwork) and overlaid on parcels produced by Chaffee County. The resource described by this survey form is darkly shaded.
