# Architectural Inventory Form

1. Resource Number: 5CF2295  
 2. Temporary Resource Number: 75  
 3. County: Chaffee  
 4. City: Salida  
 5. Historic Building Name: Sweeney/McCormick House  
 6. Current Building Name: N/A  
 7. Building Address: 407 E. Second Street  
 8. Owner Name and Address: McCormick, Robert H., P.O. Box 478, Salida, CO 81201
- Parcel Number: 380705128053  
 SHF/CLG Grant Number: CO-06-017

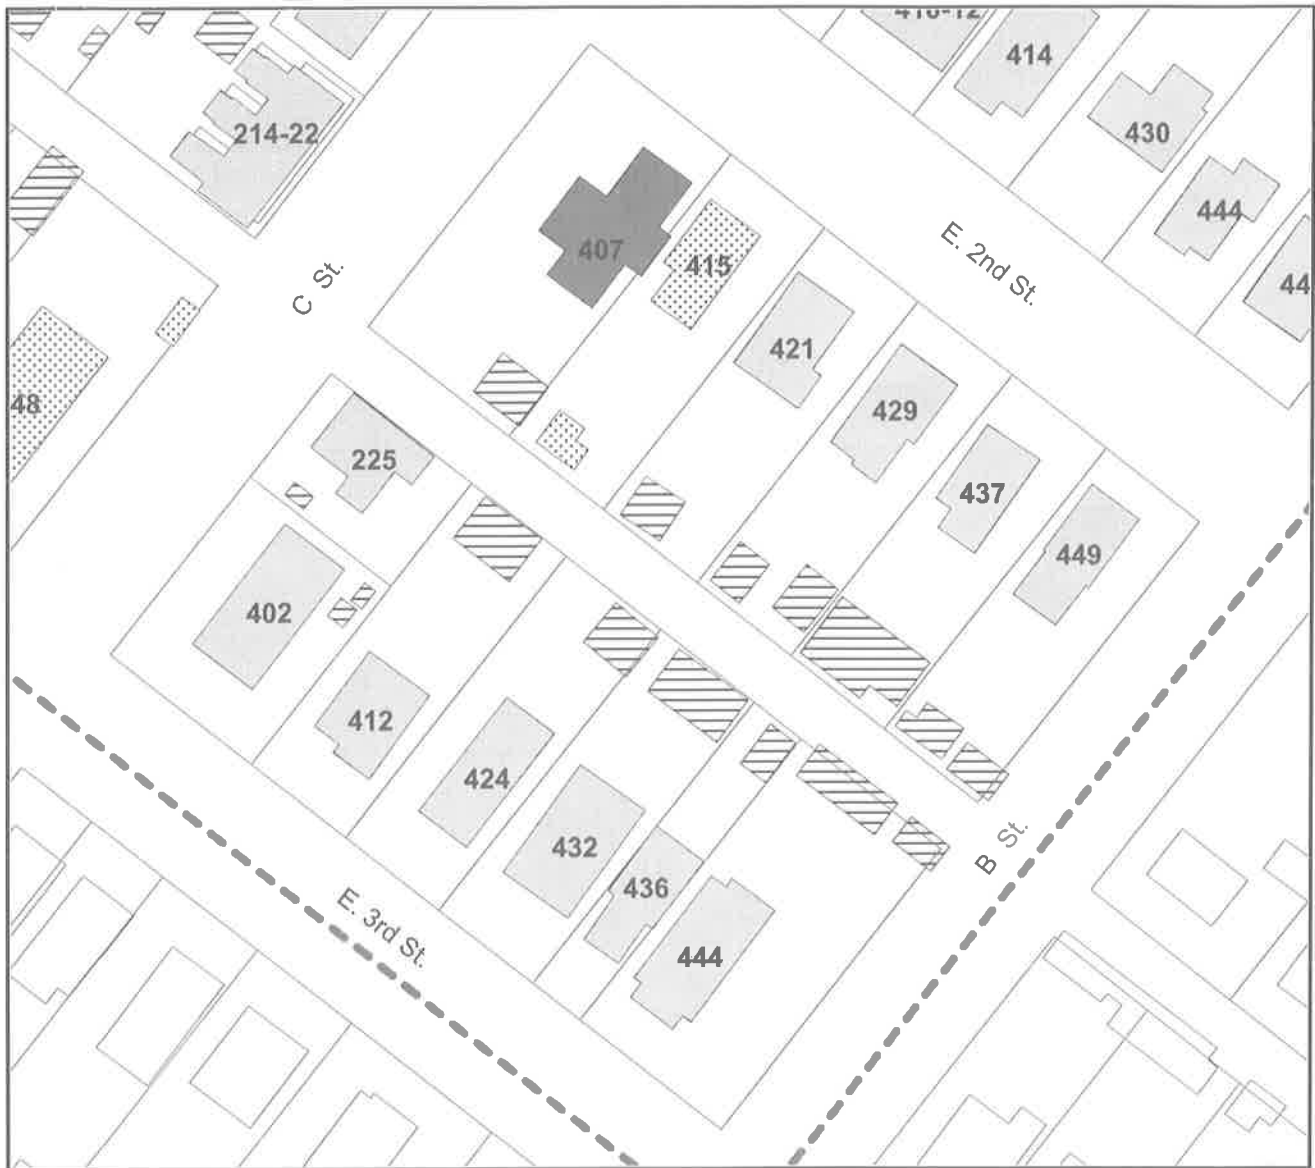
407 E. Second Street

SOURCE: Building outlines from CAD file provided by City of Salida (and supplemented by fieldwork) and overlaid on parcels produced by Chaffee County. The resource described by this survey form is darkly shaded.
