COLORADO CULTURAL RESOURCE SURVEY

Architectural Inventory Form

1. **Resource Number:** 5CF2280
2. **Temporary Resource Number:** 202
3. **County:** Chaffee
4. **City:** Salida
5. **Historic Building Name:** Nash/Shirk House
6. **Current Building Name:** N/A
7. **Building Address:** 234 E. Second Street
8. **Owner Name and Address:** Drennen, Michael J. and Spezze-Drennen, Tamrie, 1912 Griffith Pl., Longmont, CO 80501
- Parcel Number:** 380705123005
SHF/CLG Grant Number: CO-06-017

8. Report Title: Salida, Colorado, Historic Buildings Survey, 2006-07

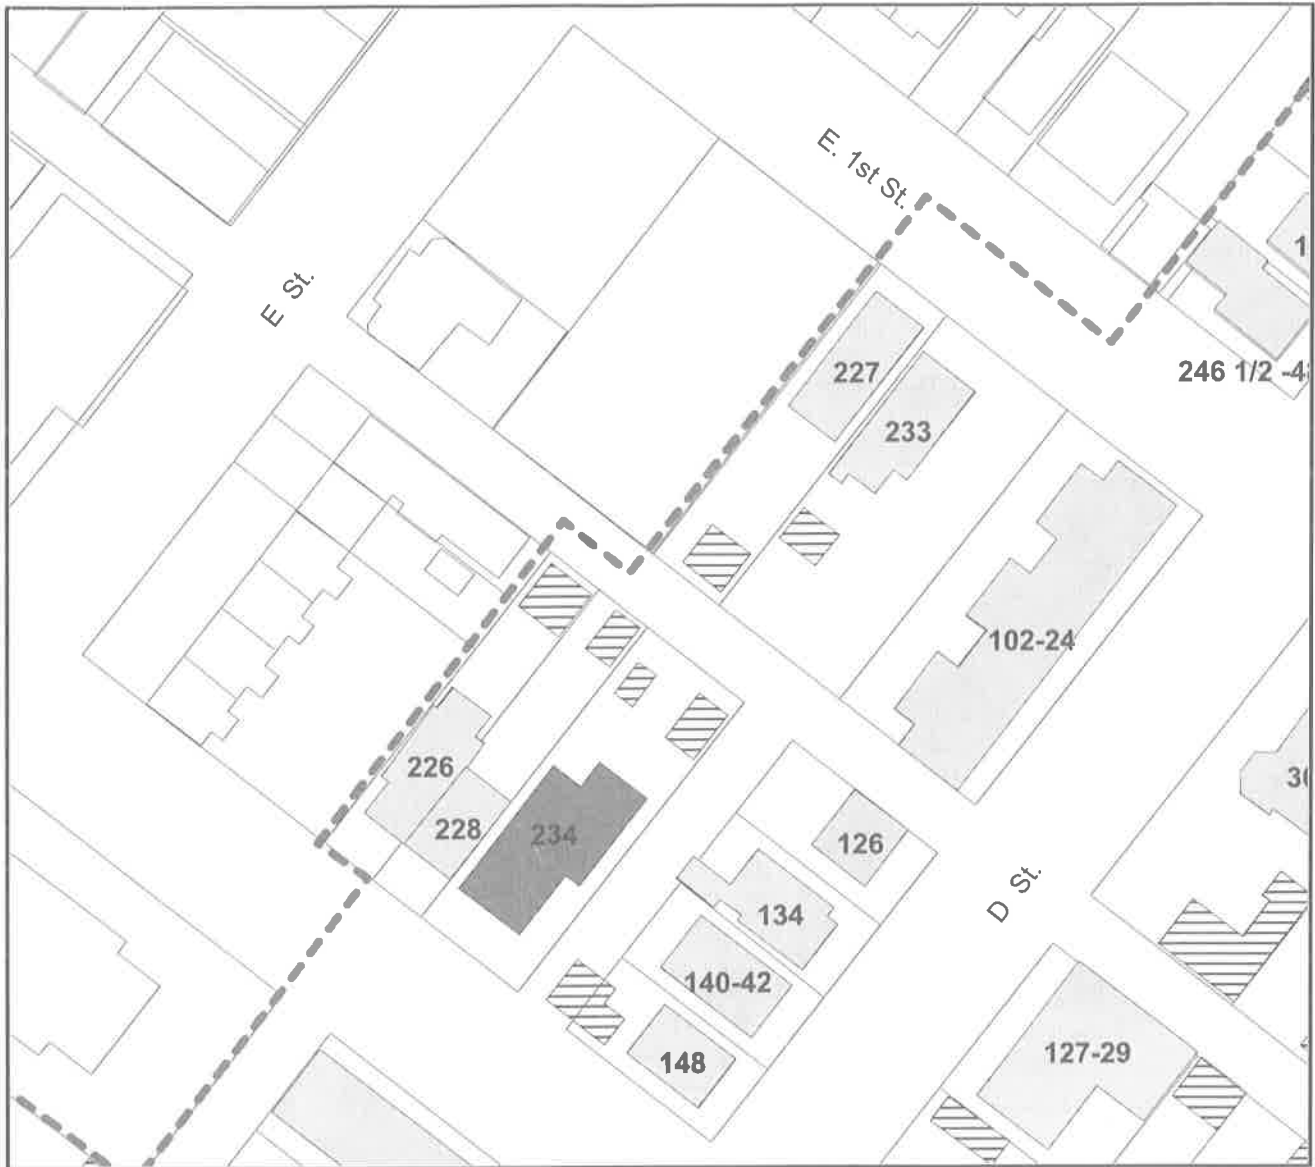
234 E. Second Street

SOURCE: Building outlines from CAD file provided by City of Salida (and supplemented by fieldwork) and overlaid on parcels produced by Chaffee County. The resource described by this survey form is darkly shaded.
