ARCHITECTURAL/HISTORICAL COMPONENT FORM

1) Resource No. 5CF242 2) Temp No. 31 3) Name Commercial Building
 4) Address 100 blk. E First, south side 5) District Name Salida Commercial District
 I. INTEGRITY: 6) Condition: Good Fair Deteriorated
 7) Original Use commercial property 8) Present Use commercial property
 9) Original Site Moved Date(s) of Move: _____
 10) Unaltered Altered Explain: Stucco and brick cover portions of lower facade.

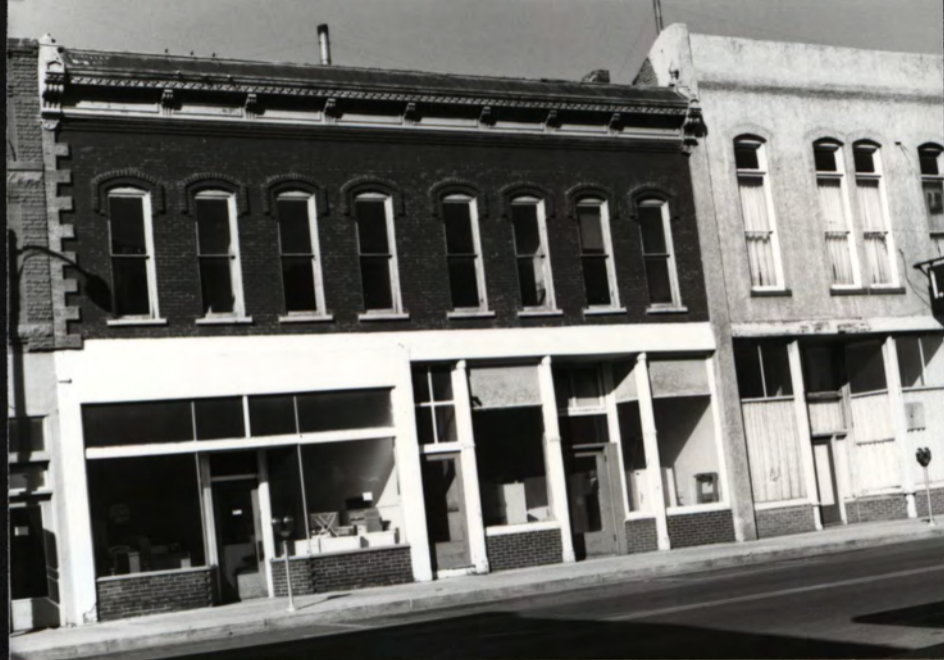
Frame Number	<u>8</u>
Roll Number	<u>CF6</u>
Facade Orientation	<u>N</u>

Listed as the Bowne Block on the 1888 Sanborn map, this structure features a bracketed metal cornice, and eight segmental arch openings accented by brick window hoods. Stucco and brick obscures a large portion of the original storefront area which retains its recessed entrances and display window areas.
