ARCHITECTURAL/HISTORICAL COMPONENT FORM

1) Resource No. 5CF302 2) Temp No. 91 3) Name Hot Springs Trading Co./Art Gallery
4) Address 131 E. First 5) District Name Salida Commercial District

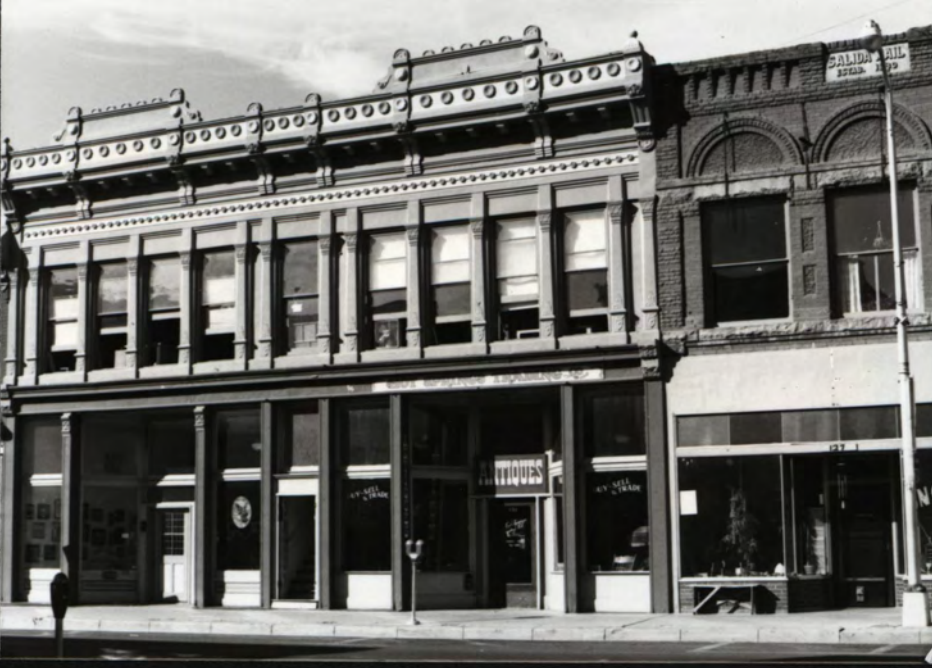
Frame Number 10
 Roll Number CF6
 Facade Orientation N

Providing another example of a stamped metal facade, this two story brick commercial structure originally housed a grocery and clothing store with furnished rooms on the second floor. (See resource no. 5CF267 for history of metal facades)

This metal facade (the name of the distributor was not found) features a richly decorated, bracketed cornice, pilasters separating the nine second story bays, and metal supports at the ground level. Two storefronts with recessed entrances and large display windows and a central entrance to the second floor dominate the lower facade.
