ARCHITECTURAL/HISTORICAL COMPONENT FORM

- 1) Resource No. 5CF255 2) Temp No. 44 3) Name Cady's Hardware  
 4) Address 139 F Street 5) District Name Salida Commercial District  
 I. INTEGRITY: 6) Condition: Good  Fair  Deteriorated   
 7) Original Use commercial property 8) Present Use commercial property  
 9) Original Site  Moved  Date(s) of Move: \_\_\_\_\_  
 10) Unaltered  Altered  Explain: Brick siding over kickplates (panels  
beneath display windows)

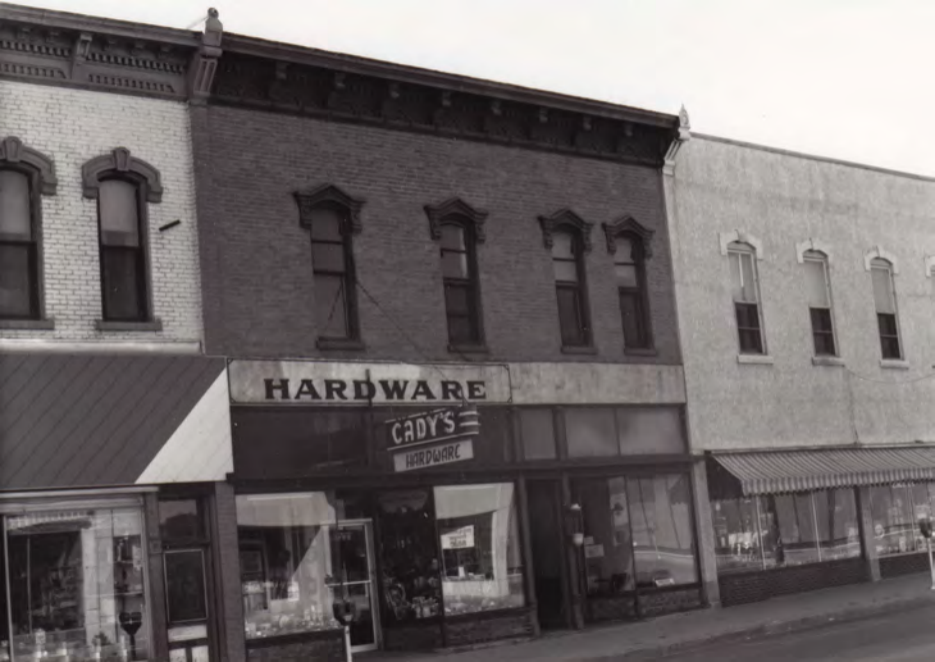
Frame Number 13  
Roll Number CF3  
Facade Orientation W

A two story brick commercial building distinguished by a bracketed metal cornice and four asymmetrically arranged segmental arch bays. (the arrangement of the bays reflects the division of the store areas). The windows are highlighted by ornate caps. The lower storefront area is largely intact and even the Hardware sign remains. According to the 1890 Sanborn map, the hardware store shared the building with a millinery shop.
