ARCHITECTURAL/HISTORICAL COMPONENT FORM

- 1) Resource No. 5CF216 2) Temp No. 5 3) Name The Palace Hotel
 4) Address 204 North F 5) District Name Salida Commercial District
 I. **INTEGRITY:** 6) Condition: Good Fair Deteriorated
 7) Original Use commercial property 8) Present Use commercial property
 9) Original Site Moved Date(s) of Move: _____
 10) Unaltered Altered Explain: Display windows modified. Brick and wood siding over kickplates (panels beneath display windows)

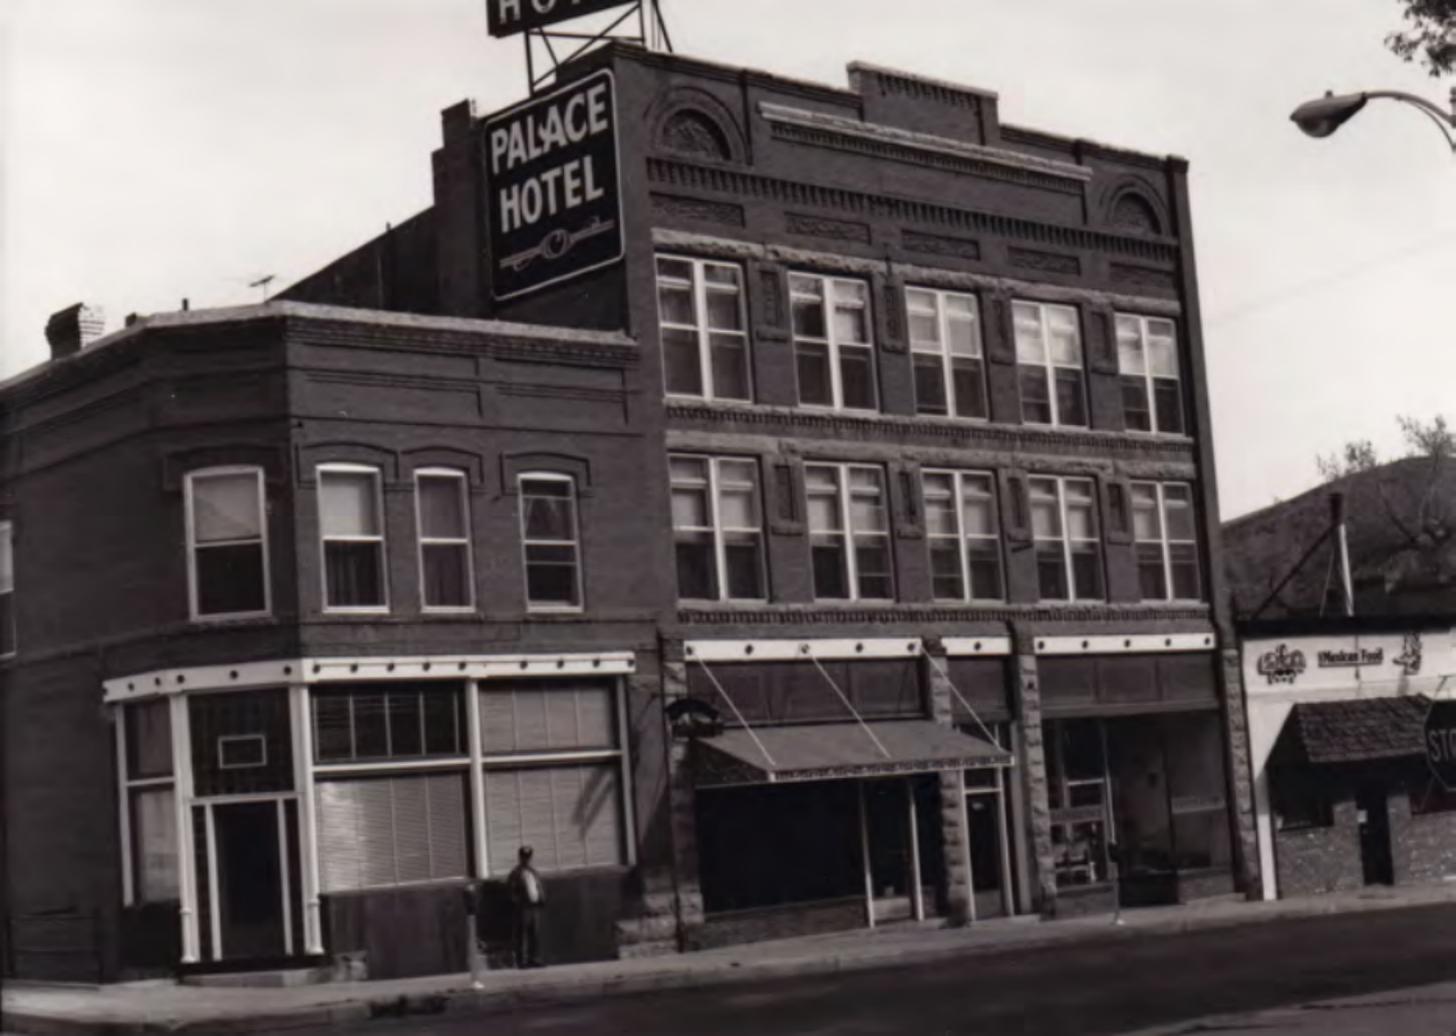
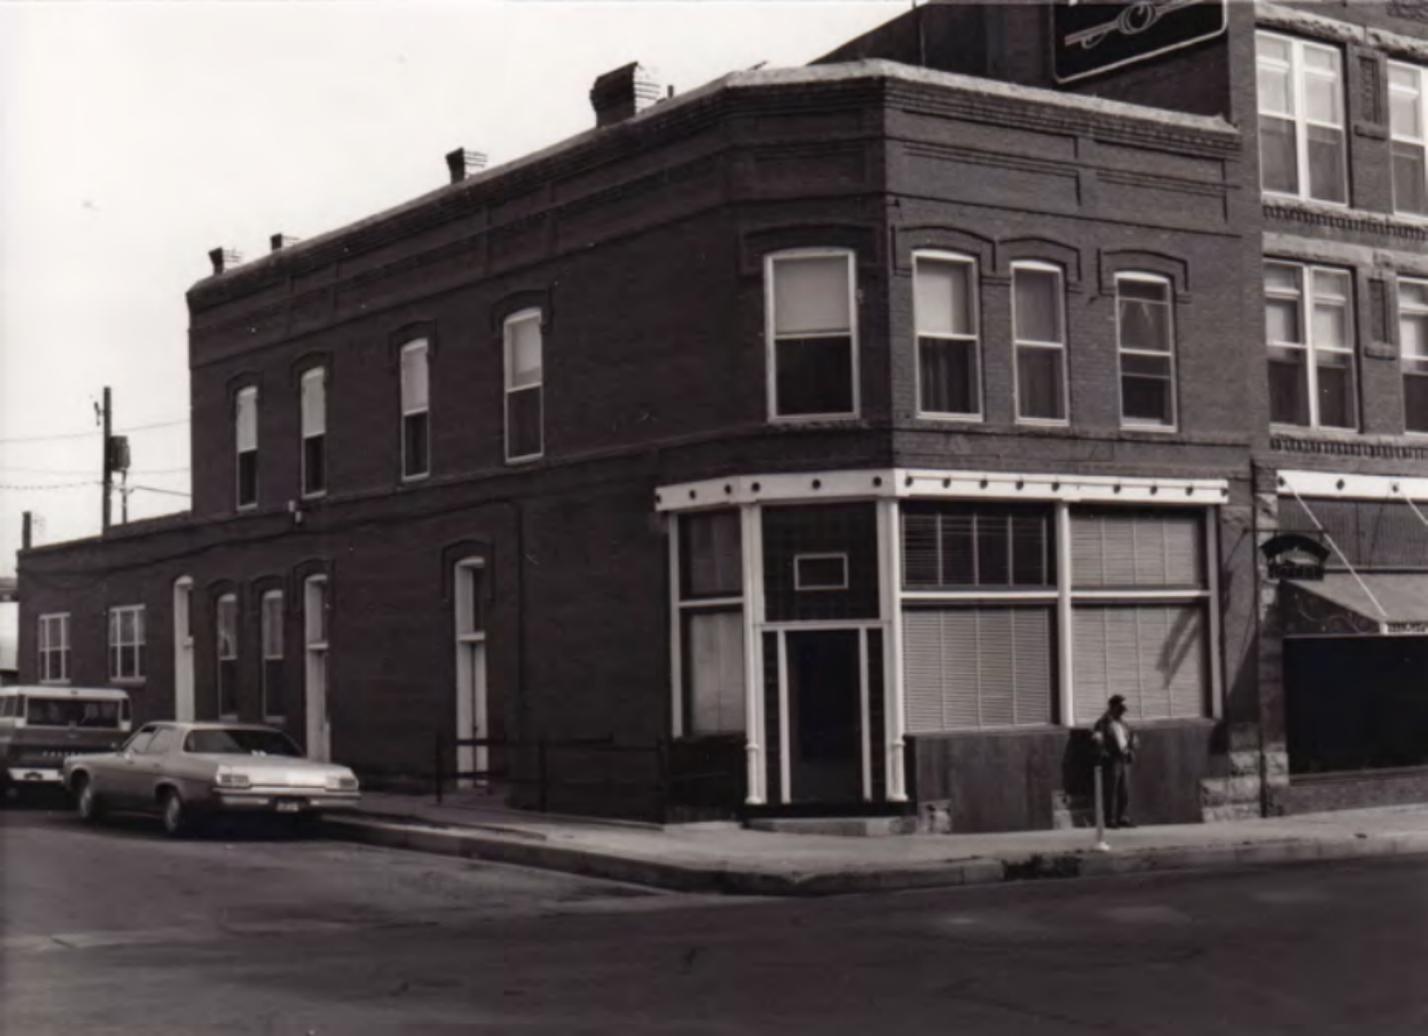
Frame Number 6,7
Roll Number CF1
Facade Orientation E

The Palace Hotel, built by Delacy Ramsey and completed in 1909 (The two story corner portion is on the 1904 Sanborn map) is an imposing three story brick structure with a two story corner section. The hotel is distinguished by various brickwork patterns (corbelling, etc.) at the cornice. On the second and third floors are five sets of paired openings demarked by rough cut stone stringcourses. A metal lintel separates the upper stories from the storefront area which features two commercial entrances flanking a center entrance to the hotel rooms. Columns of cut stone frame the hotel entrance and mark the sides of the storefront.

The corner section features three bays defined by brick window hoods. A single bay highlights the building's corner entrance. The storefront is largely intact, although the display windows have been partially covered.
