ARCHITECTURAL/HISTORICAL COMPONENT FORM

- 1) Resource No. 5CF306 2) Temp No. 95 3) Name Salida Drafting
 4) Address 246 E. First Street 5) District Name n/a
 I. INTEGRITY: 6) Condition: Good Fair Deteriorated
 7) Original Use private residence 8) Present Use commercial property
 (as denoted on Sanborn maps)
 9) Original Site Moved Date(s) of Move: _____
 10) Unaltered Altered Explain: New aluminum windows

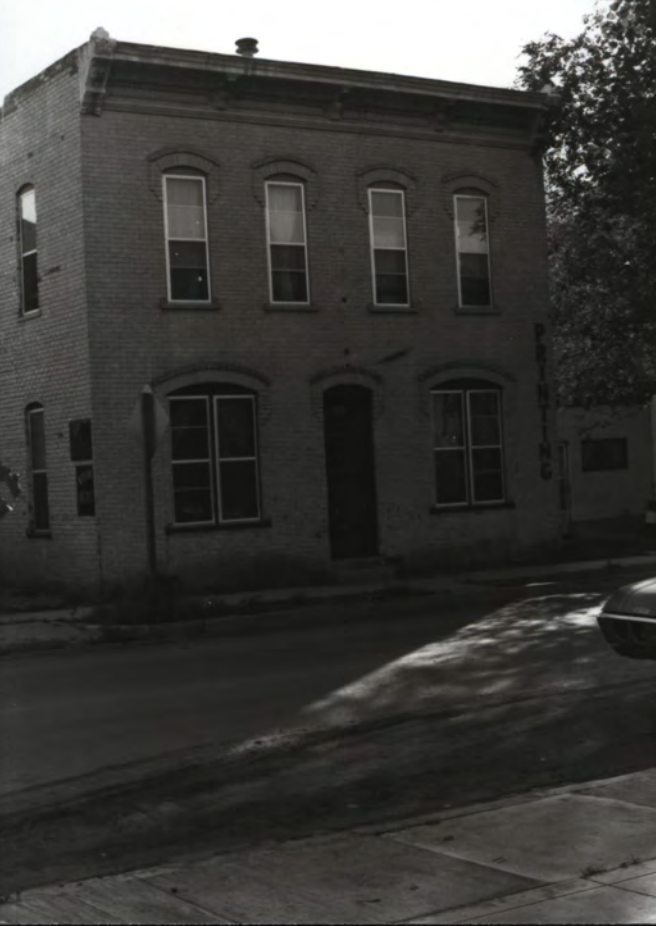
Frame Number	<u>8</u>
Roll Number	<u>CF 7</u>
Facade Orientation	<u>S</u>

- II. DESCRIPTION: 11) Building Materials brick
 12) Construction Date 1898-1904 13) Architect/Builder unknown
 (1898, 1904 Sanborn Perris maps)
 14) Architectural Style(s) n/a
 15) Special Features/Surroundings: Signs for "Best Rooms" and "Steam Heat" on west wall.

A two story brick structure characterized by a bracketed metal cornice and segmental arch openings - four second floor bays and, on the ground level, a central entrance flanked by paired bays. The Sanborn maps list the building as a dwelling but the "Best Rooms" and "Steam Heat" signs on the building's west wall indicate that the structure was a hotel or at the least offered furnished rooms on the second floor.
