National Register of Historic Places  
Inventory—Nomination Form

historic Chaffee County Poor Farm

and/or common Poor Farm Country Inn

Chaffee County Poor Farm  
Chaffee County, Colorado

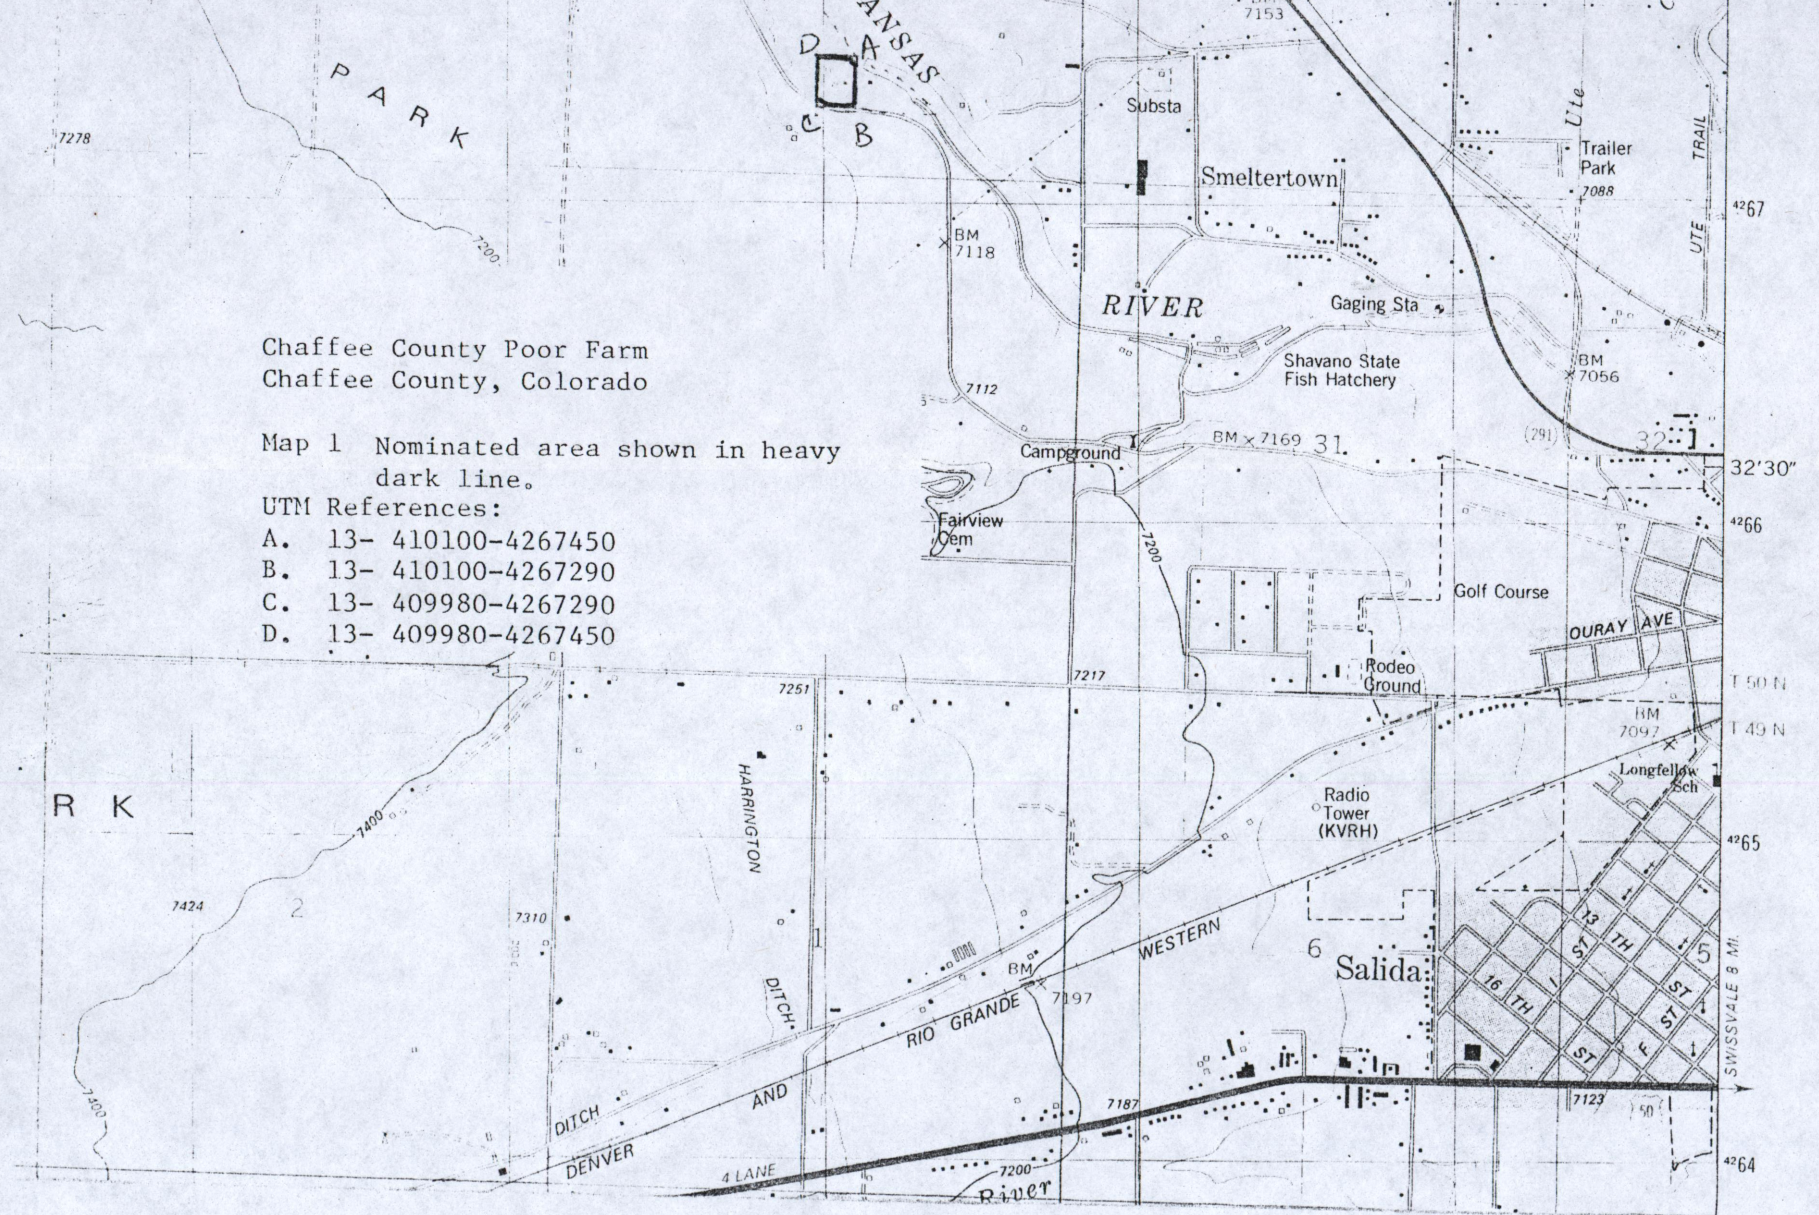
Map 1 Nominated area shown in heavy  
dark line.

- A. 13- 410100-4267450
- B. 13- 410100-4267290
- C. 13- 409980-4267290
- D. 13- 409980-4267450

**Verbal boundary description and justification** Included within the nominated area was the poor house and open fields immediately surrounding to reflect the rural "farm" nature of the resource. Part of the SW $\frac{1}{4}$  and part of the NW $\frac{1}{4}$ , SE $\frac{1}{4}$ , Sec. 25, T50N, R8E, N.M.P.M. as described at entry No. 10 herein. (See Map 2 for precise boundaries)

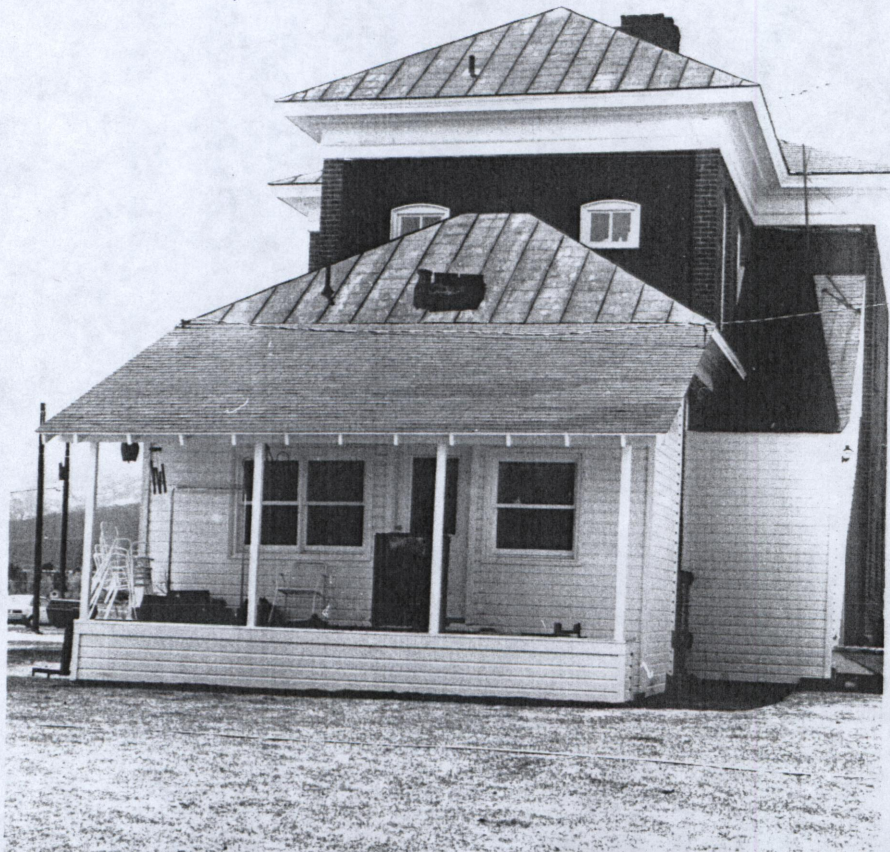
Photo 6

Camera Direction: north (rear) elevation  
(1945 addition shown)

The sheer bulk of the house is not apparent from the 36 foot wide south facade which forms the top of the T. From the side elevations, however the 84 foot length is seen with a two-story section forming the stem of the T by means of a set-back from the side walls of the front section and ending at the bottom of the T in a one-story hipped roof section which has a 1945 shed roof, frame addition with a porch.

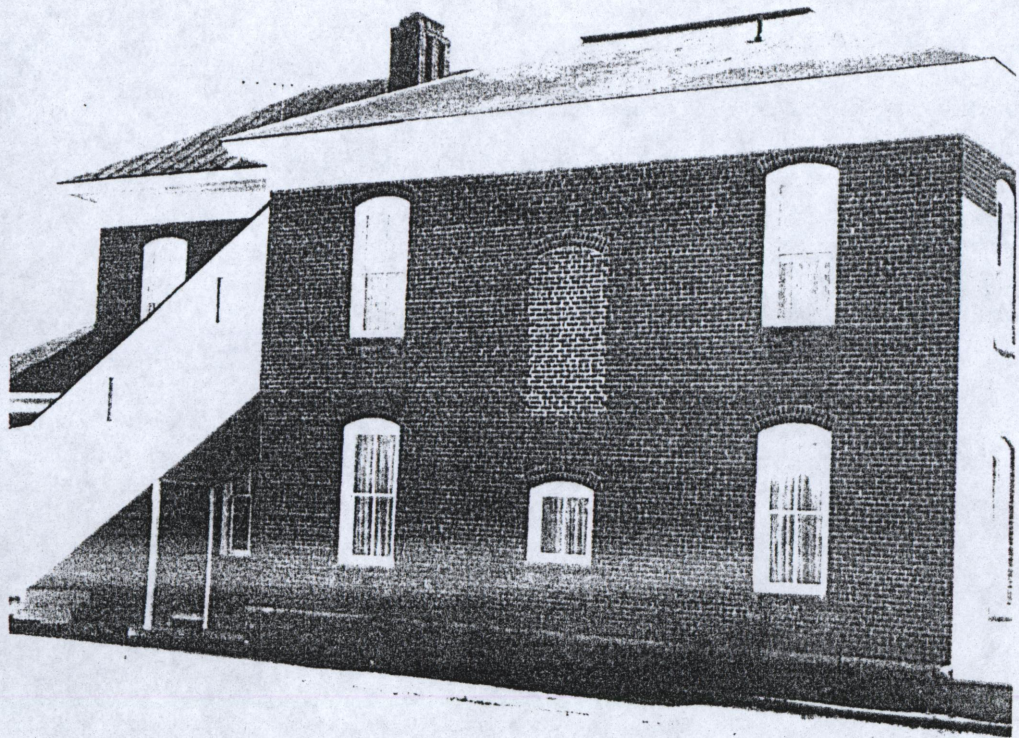
Property Name: The Chaffee County Poor F  
Location: Vicinity Salida, Colorado  
(Chaffee County)  
Photographer/Date: Ray James/April, 1984  
Negative: 8495 County Road 160, Salida, Co.  
Camera Direction: view looking northeast  
Photo No.: 5

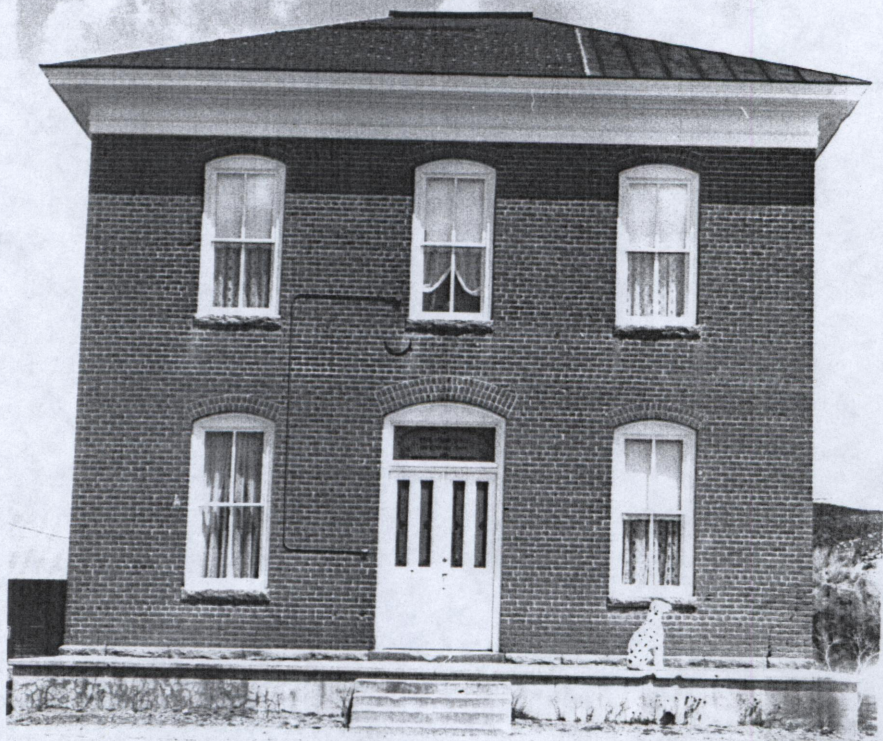
Photo No.: 2

Camera Direction: (front) south elevation look-  
ing north

The front entrance on the south is centrally located and is flanked by one window on either side. The three second floor windows are placed directly above the first floor openings. The paneled double entry doors have two narrow vertical lights in the upper portions and are set beneath a transom within a segmental arch with a triple row of headers. The front porch consists of an unroofed concrete platform without a railing. On the east side there are two doors at the second story level within the set-back which give access to a metal chute or slide used as a fire escape.

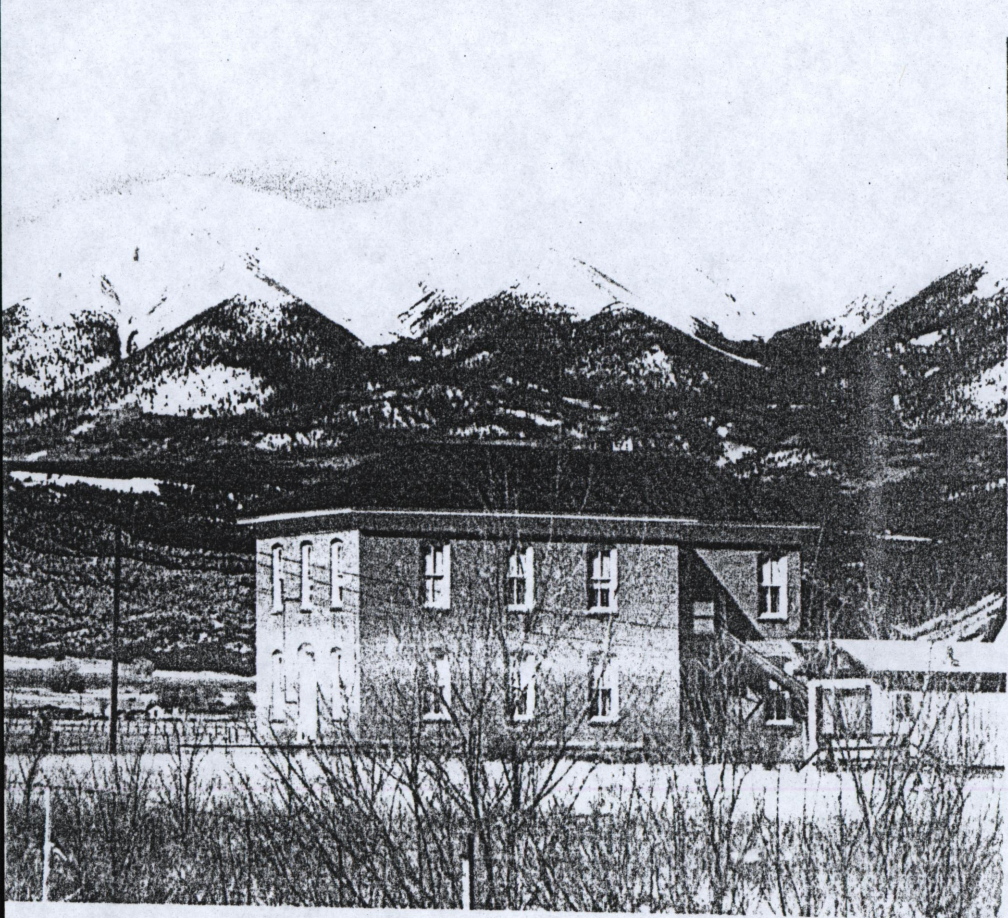
Property Name: The Chaffee County Poor Farm  
Location: Vicinity Salida, Colorado  
(Chaffee County)  
Photographer/Date: Ray James/April, 1984  
Negative: 8495 County Road 160, Salida, Colorado  
Camera Direction: view looking west  
Photo No.: 1

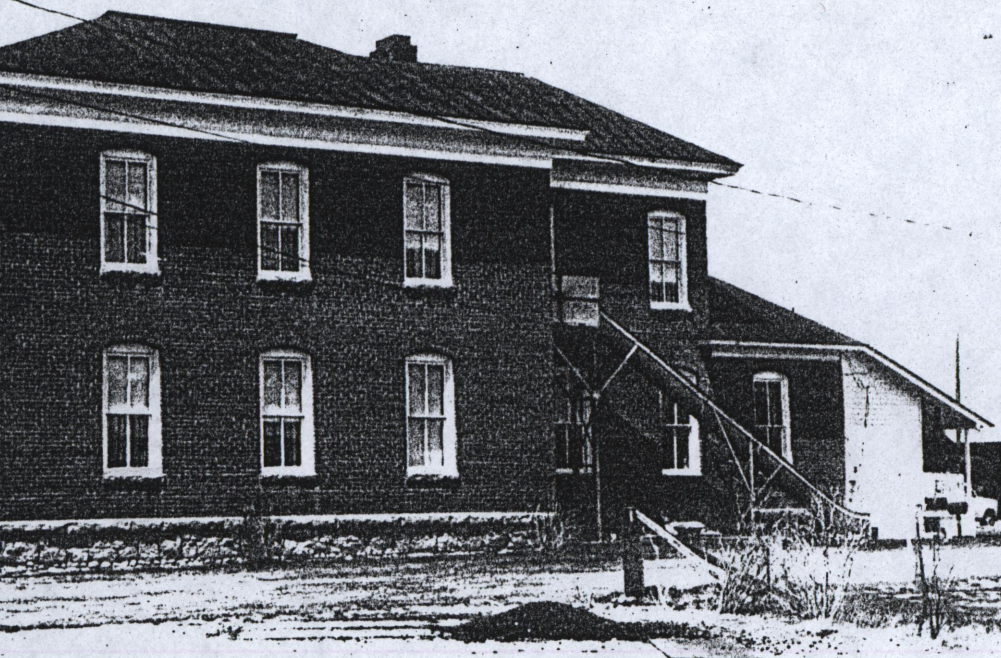
Property Name: The Chaffee County Poor Farm  
Location: Vicinity Salida, Colorado  
(Chaffee County)  
Photographer/Date: Ray James/April, 1984  
Negative: 8495 County Road 160, Salida, Colorado  
Camera Direction: view looking northwest  
Photo No.: 3

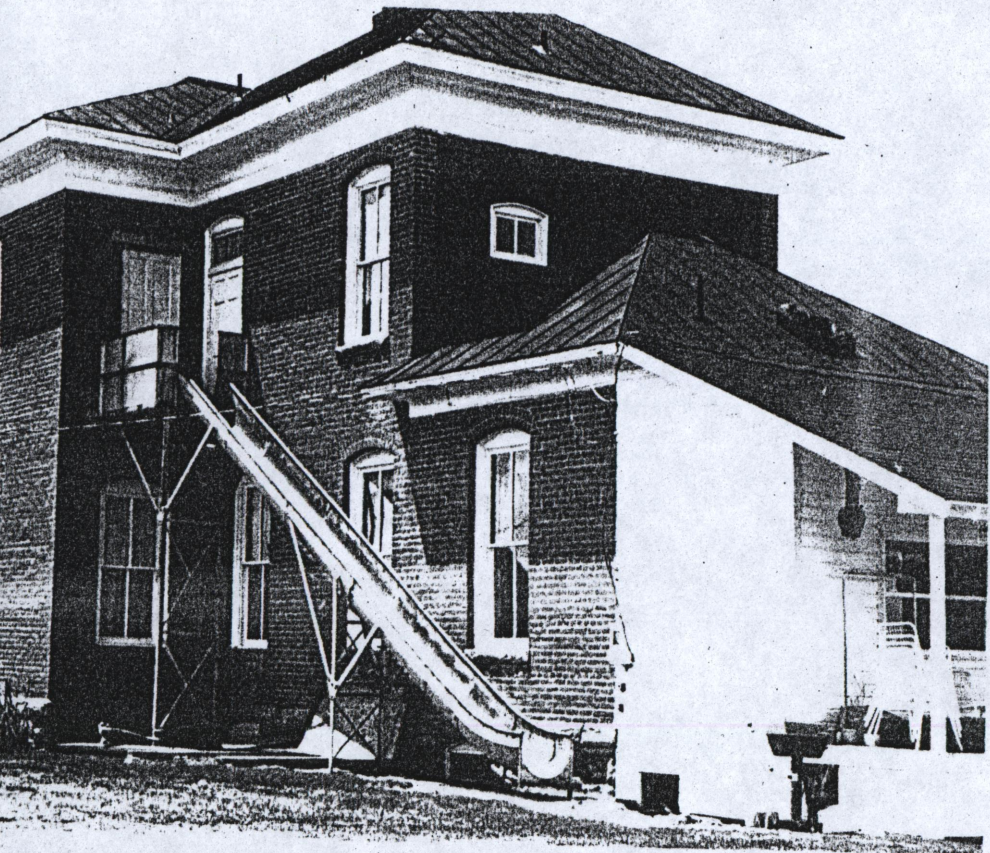
Property Name: The Chaffee County Poor Farm  
Location: Vicinity Salida, Colorado  
(Chaffee County)  
Photographer/Date: Ray James/April, 1984  
Negative: 8495 County Road 160, Salida, Colo  
Camera Direction: view looking southwest  
Photo No.: 4
